Report of Survey

BI-VALVE

1987 Whiteline Marine Aluminum 26' C/C

29 December 2022

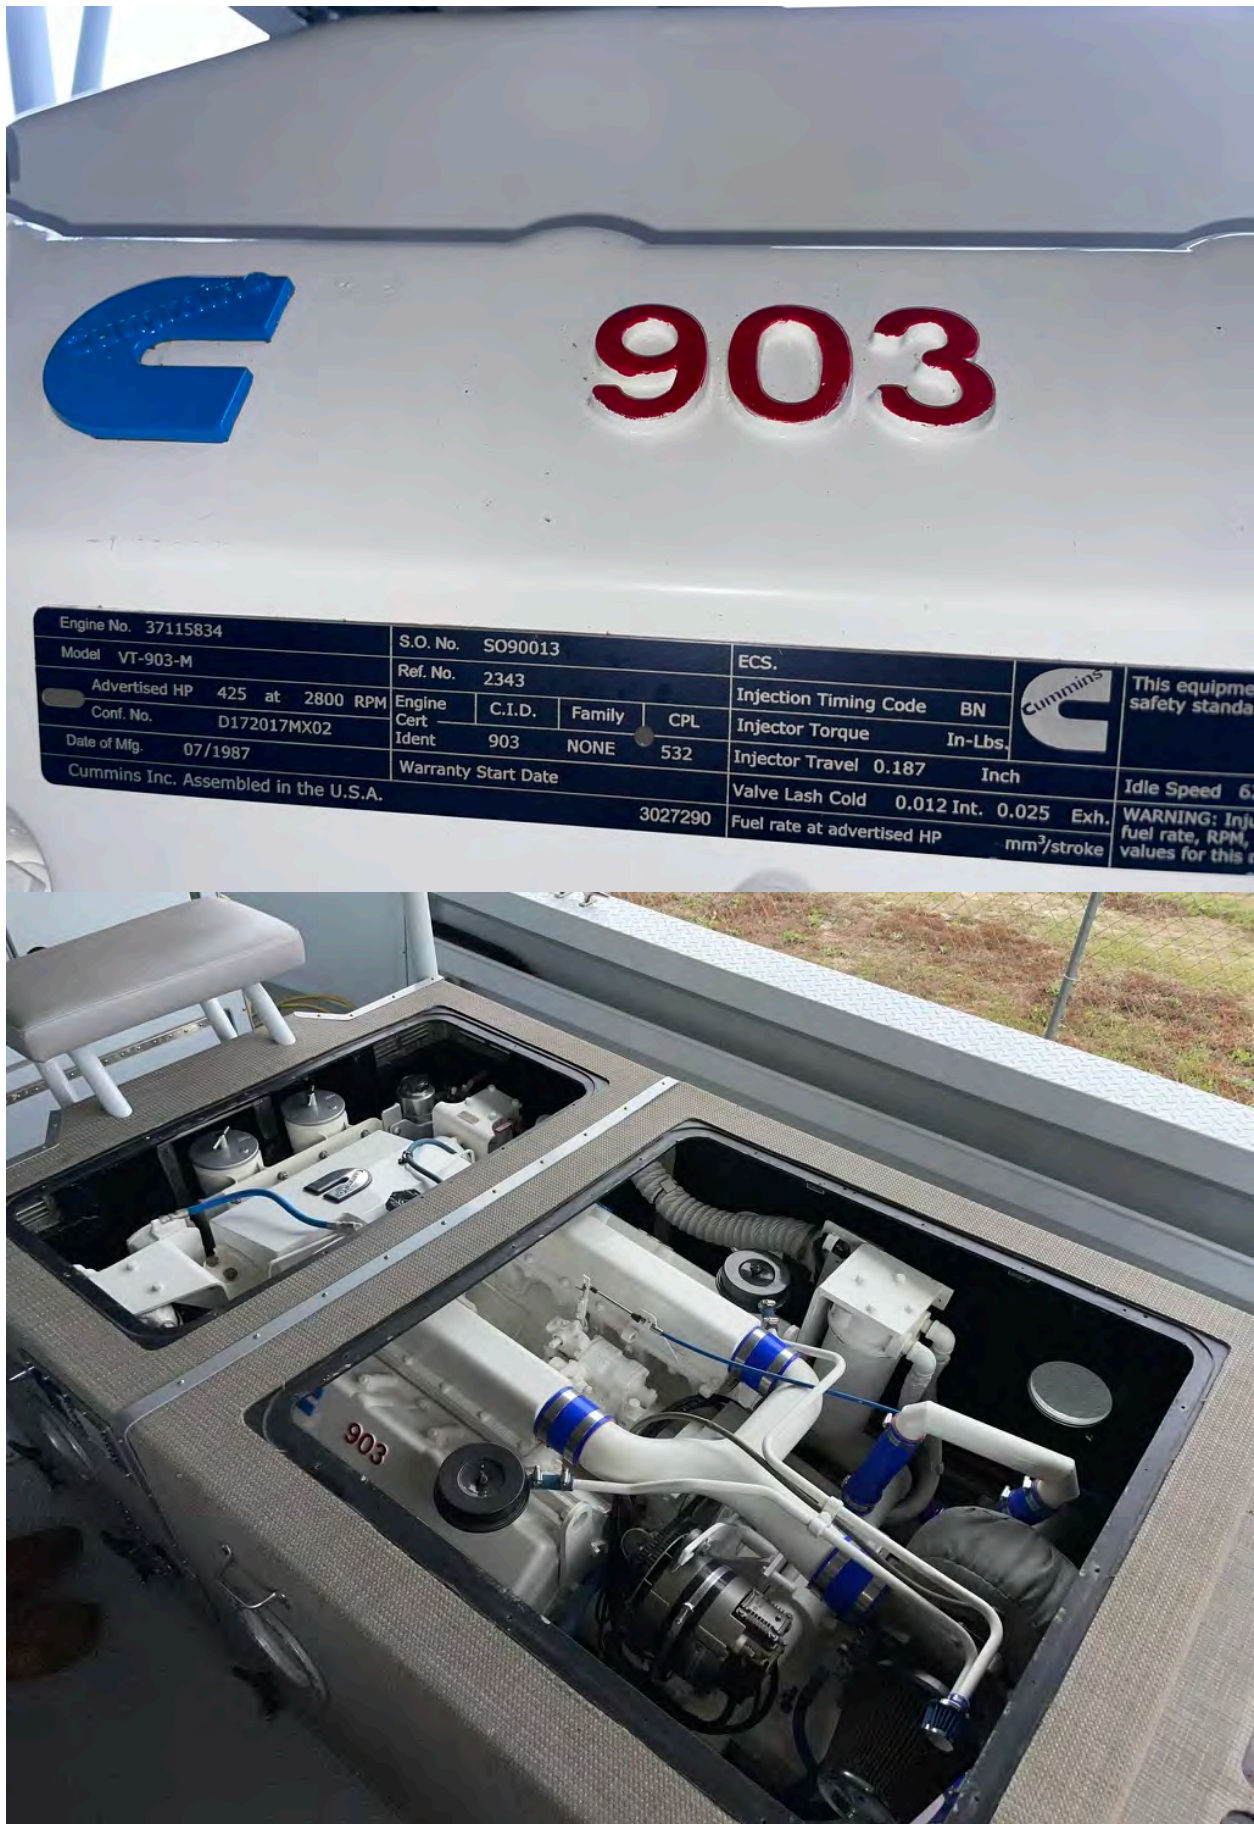
Engine No. 37115834		S.O. No. S090013			ECS.		Cummins	This equipment safety standards
Model VT-903-M		Ref. No. 2343			Injection Timing Code BN			
Advertised HP 425 at 2800 RPM		Engine Cert	C.I.D.	Family	CPL	Injector Torque In-Lbs.		Idle Speed 6
Conf. No. D172017MX02		Ident	903	NONE	532	Injector Travel 0.187 Inch		
Date of Mfg. 07/1987		Warranty Start Date			Valve Lash Cold 0.012 Int. 0.025 Exh.		WARNING: Inj fuel rate, RPM, values for this	
Cummins Inc. Assembled in the U.S.A.		3027290			Fuel rate at advertised HP mm ³ /stroke
